The Town of Whitby

Bridge and Culvert Master Plan Environmental Study Report

Final Report – May 2021

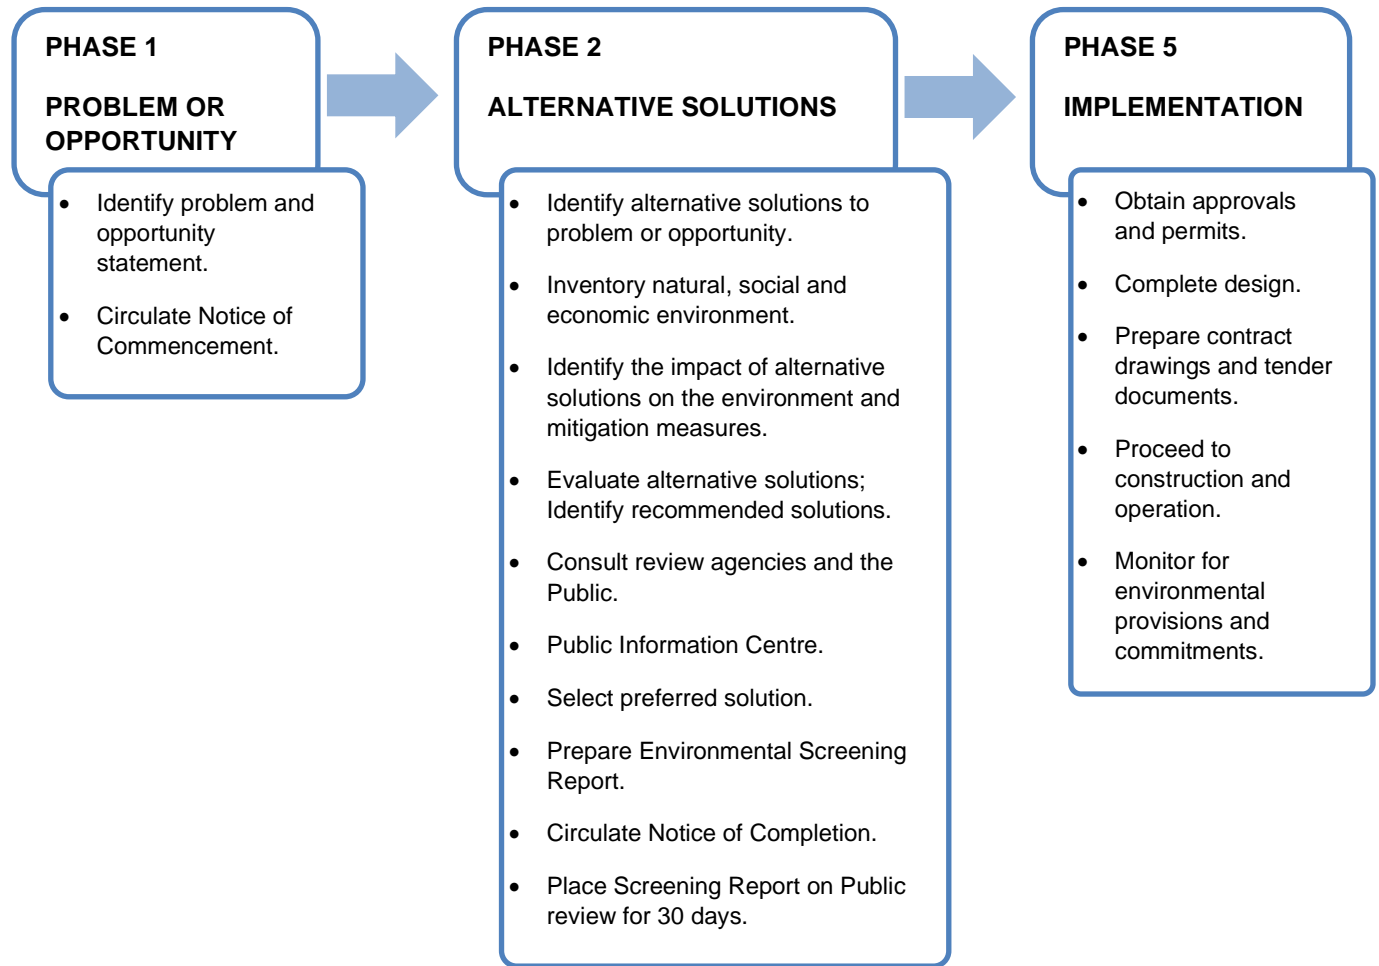
Figure 2-2. Municipal Class Environmental Assessment Planning and Design Process for Schedule B Projects (modified from MEA, 2007).

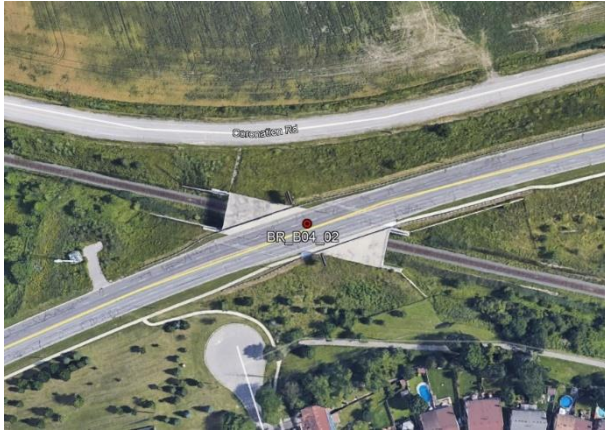
Photograph 1: Bridge BR_B04_02 at Rossland Road West

These bridges are rail or road bridges at rail grade separations and are not watercourse crossings. Therefore, the bridges have not been included in this Master Plan. Photos of the bridges are presented below.

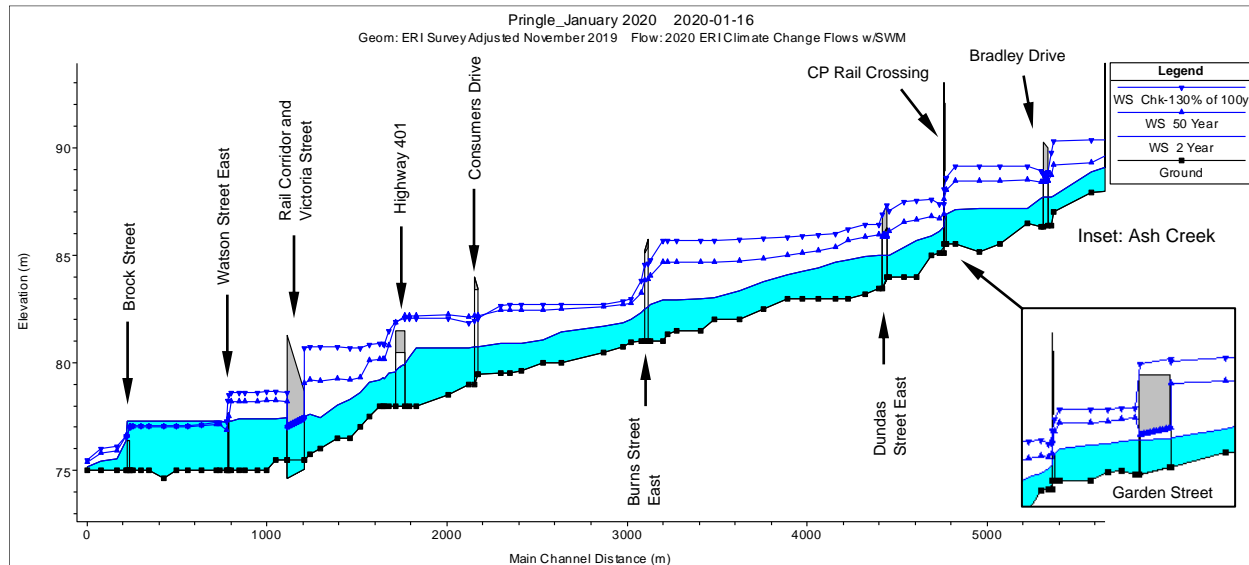
Figure 8-2. Pringle Creek Water Surface Profile from Lake Ontario to Bradley Drive – Future Controlled Flows. Inset: Ash Creek from the CNR Rail Crossing to Garden Avenue.

Based on this review, it was determined that the Pringle Creek regulated crossings should be designed based on the future controlled flows, accounting for the peak flow control provided by future stormwater management infrastructure that is required under provincial and municipal legislation and guidelines.

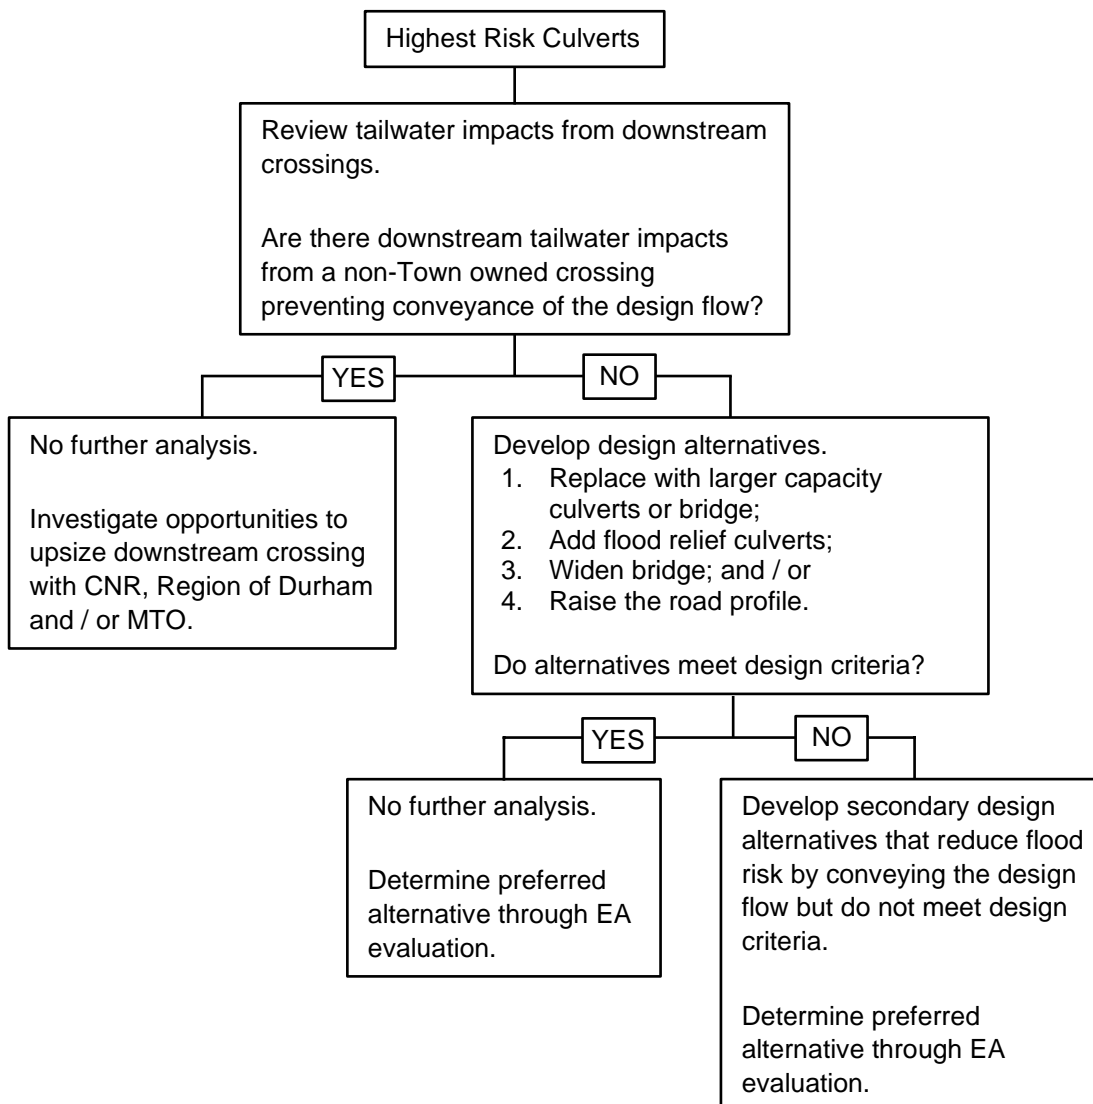
Figure 9-1. Design Alternative Development Methodology Flow Chart.

The opportunities and constraints associated with addressing hydraulic capacity to meet the design criteria are unique at each crossing. Therefore, a consistent and repeatable approach is required for the study. The methodology for developing design alternatives at each crossing is presented in **Figure 9-1**. The primary objective of the proposed conditions analysis is to identify feasible design alternatives that meet the design criteria. Where site constraints prevent the development of a feasible design alternative that meets the design criteria, secondary design alternatives were identified within the site constraints to increase hydraulic capacity and reduce flood risk by preventing the road overtopping during the design flow.

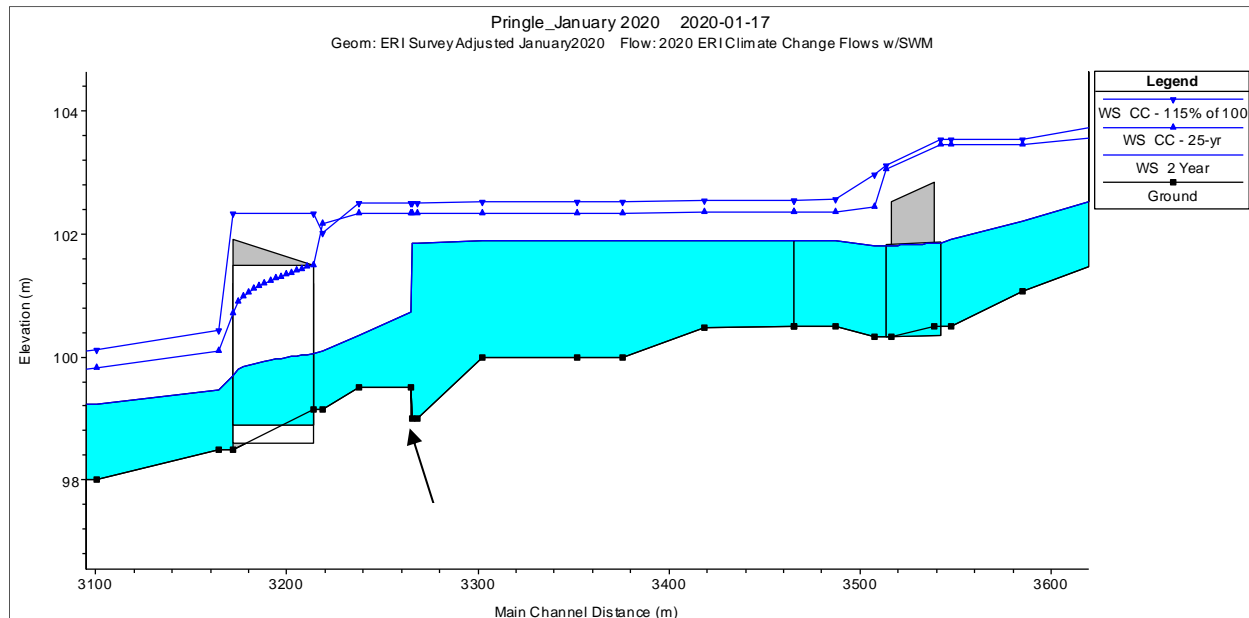
Figure 9-2. Water Surface Profile for Pringle Creek and the Pringle Creek East Tributary from Rossland Road East to Anderson Street (Culvert CU_B04_04).

The high design flow and check flow downstream water levels are created by the Rossland Road East culvert located approximately 350 m downstream of Anderson Street, as shown **Figure 9-2**. Additionally, the Coscan Weir controls the 2-year water level at Anderson Street. Therefore, it is not feasible to reduce flood risk and meet the design criteria by upsizing the Anderson Street culvert without upsizing the Rossland Road East crossing and removing the Coscan Weir. Proposed alternatives were not considered for culvert CU_B04_04. The Town of Whitby should investigate opportunities to increase the hydraulic capacity at Rossland Road East with the Region of Durham and remove the Coscan Weir before upgrading culvert CU_B04_04.

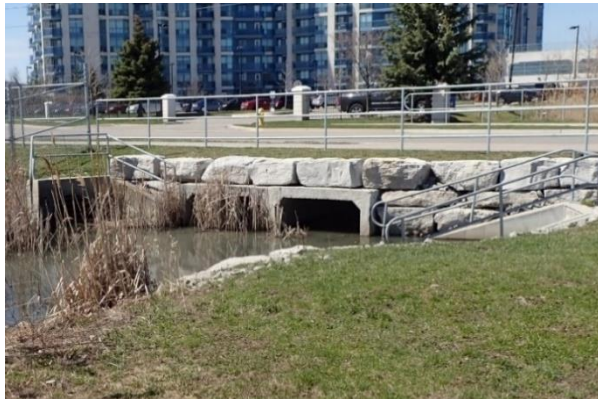
Photograph 5: Culvert CU_D01_03 outlet

require property acquisition from adjacent landowners and relocation of two storm sewer outfalls that discharge directly into the Rowe Channel downstream of the culvert outlet. Further detailed investigations are required to determine the feasibility of widening the Rowe Channel.

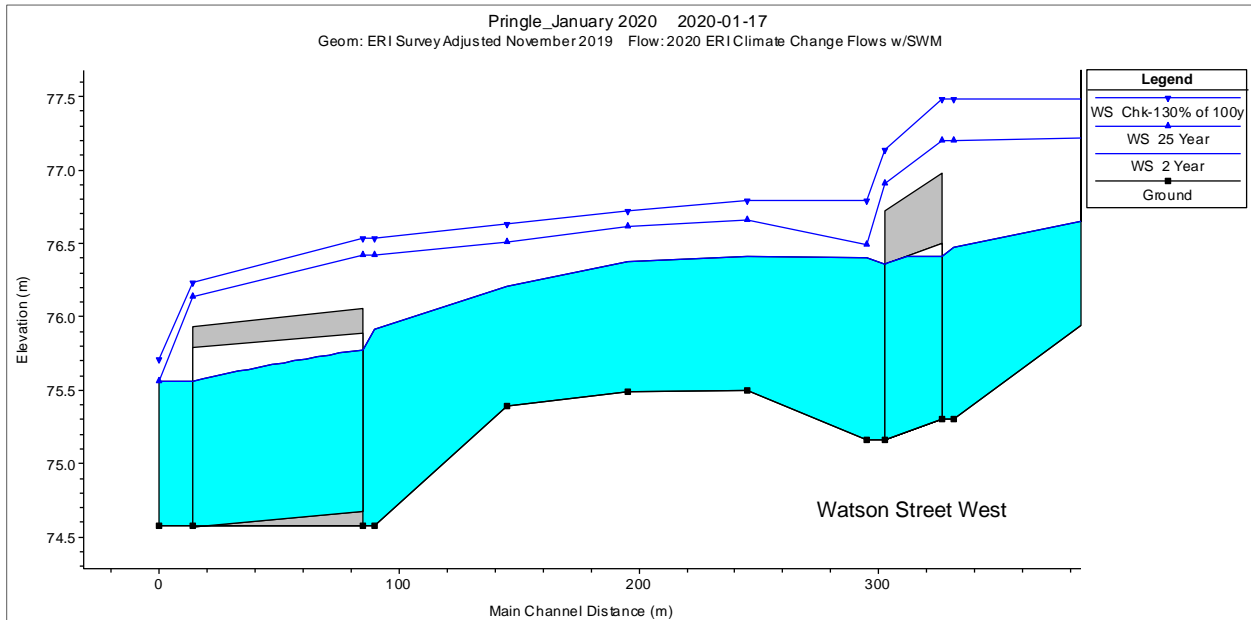
Figure 9-3. Water Surface Profile for the Rowe Channel from Lake Ontario to Watson Street West (Culvert CU_D01_03).
